Manhole Inspection Summary

Manhole # S27A__034MH

Insp Date: **11/28/07 12:52 PM**

Location Address: **625 FREMONT AVE**

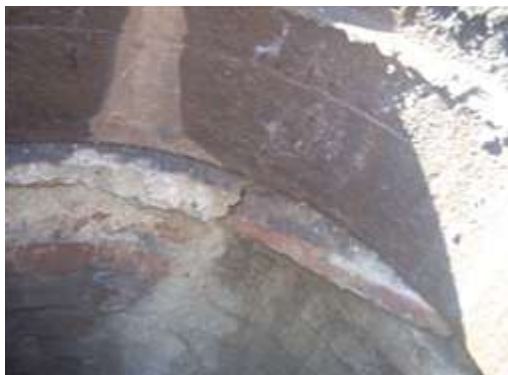
Defect 2

Condition: ☐ Sound ☐ Cracked ☐ Root Intrusion ☒ **Loose Brick** ☐ Deteriorated

LOOSE CORBEL BRICKS

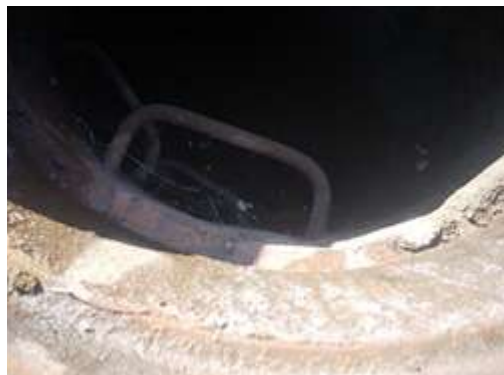
Defect 1

Frame Offset: **1** (in.) Condition: ☒ Sound ☐ Cracked ☐ Leaks

FRAME OFFSET

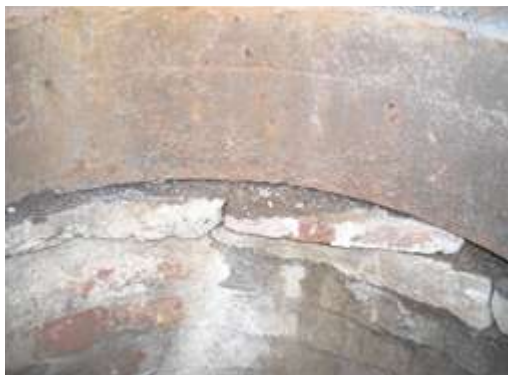
Defect 3

Comments **ADDED DEFECT PHOTO SHOWING LOOSE BRICKS IN CHIMNEY - 4-17-09**

Condition: ☐ Sound ☐ Cracked ☐ Root Intrusion ☐ Loose Brick ☒ **Deteriorated**

LOOSE BRICKS IN CHIMNEY

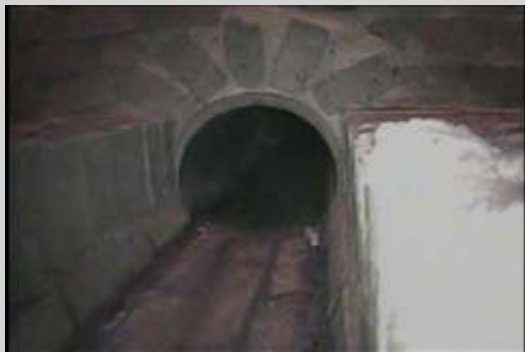
12 O'Clock Outflow

8 in. Circular Gravity Sewer
Pipe Out @ 12 O'Clock

Pipe Height: **8.4** (in.) Rod and Bar (Angled)
Pipe Material: **Clay** ☐ Pipe Lined
Invert Depth: **10.80** (ft.) Flow Characteristics: **Slow**
Deposits: ☒ None ☐ Mud ☐ Sludge ☐ Debris ☐ Grease
Silt Depth: (in.) Deposits Extent:
Infiltration: **None** Pipe Seal Cond: **Sound**

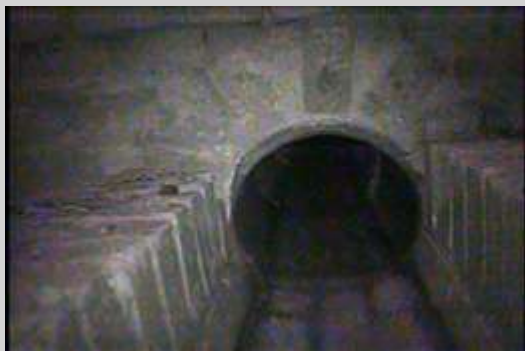
6 O'Clock Inflow

8 in. Circular Gravity Sewer
Pipe In @ 6 O'Clock

Pipe Height: **8.4** (in.) Rod and Bar (Angled)
Pipe Material: **Clay** ☐ Pipe Lined
Invert Depth: **10.63** (ft.) Flow Characteristics: **Slow**
Deposits: ☒ None ☐ Mud ☐ Sludge ☐ Debris ☐ Grease
Silt Depth: (in.) Deposits Extent:
Infiltration: **None** Pipe Seal Cond: **Sound**
